Digitalization of hay baling monitoring in Australia

PROBLEM

Big Bale Co is a leasing company offering special machinery for hay baling in Australia. It is used to press the hay and pack it into piles. The company is offering its services to farms that need to turn the grass into hay piles. Each farm usually rents equipment as the machinery is costly, around 350,000 AUD for the tractor and 250 000 AUD for the hay baler.

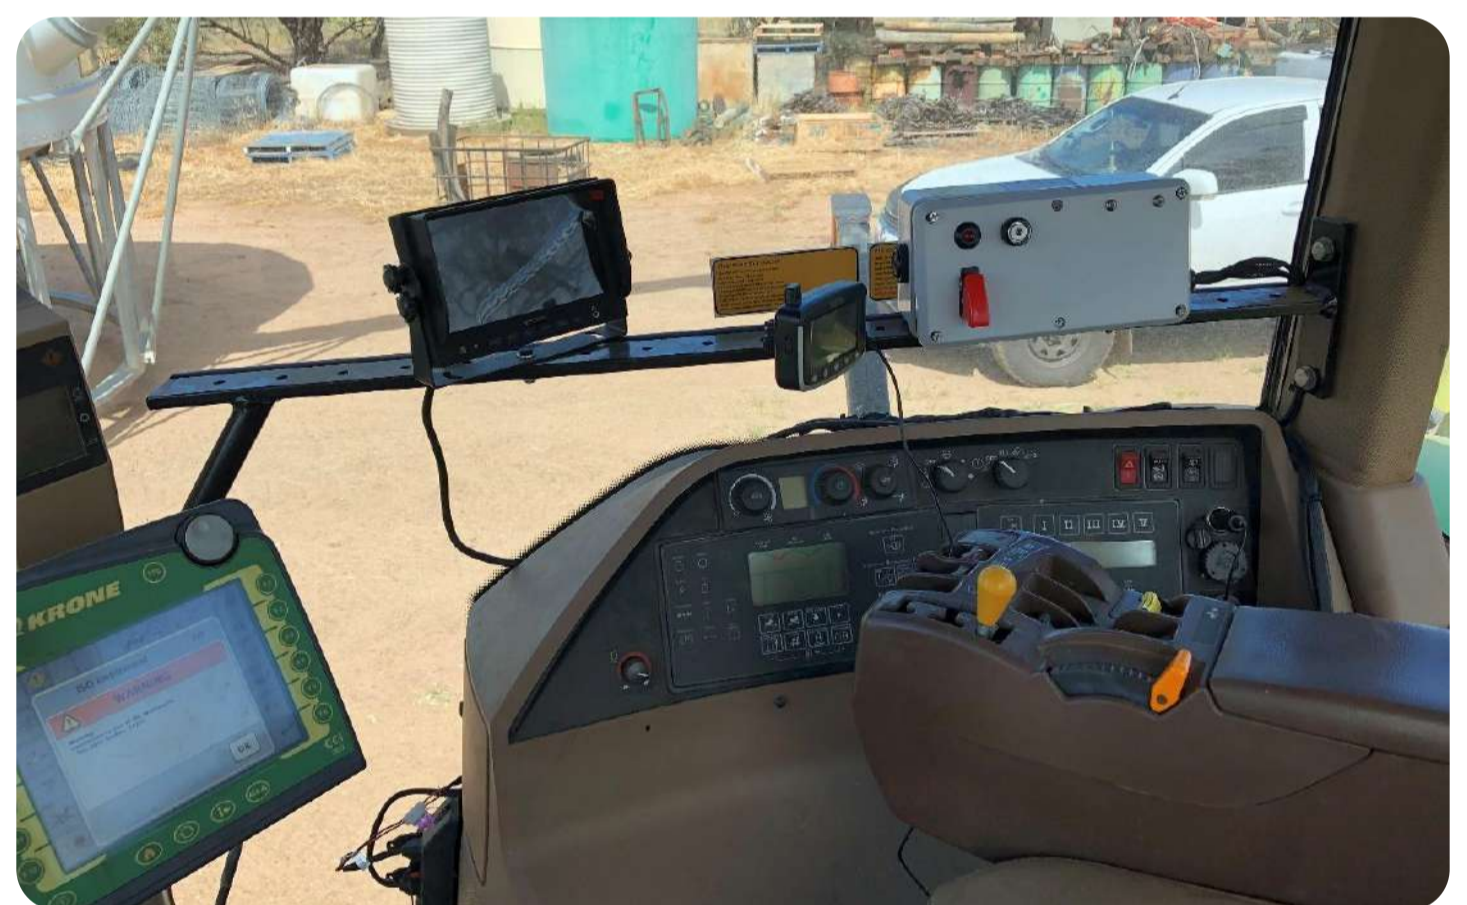
THE WHITE BOX WITH A TRACKING DEVICE, AN IBUTTON READER, AND THE BUTTON THAT A DRIVER PASSES TO RECORD REBALES

- A standard Digital Matter iButton reader was used to identify drivers and connect them to work performed.
- A buzzer was set up to notify drivers about the necessity to use identification tablets.

- A special button was installed to calculate rebales. As soon as the driver presses the button, the rebale is counted. It's also recorded in Wialon via the notifications module.
